# The Patient Centered Multimedia Radiology Report

University of Virginia Department of Radiology

# Application for thyroid nodule imaging

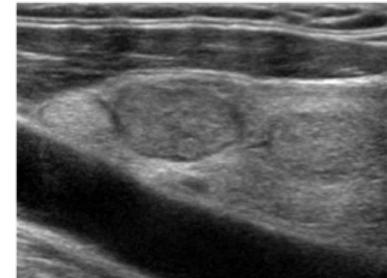
There are no thyroid nodules identified on today's exam that have imaging features concerning for cancer. One of your nodules is shown to the right.

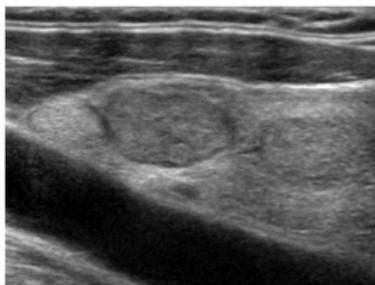
There are no thyroid nodules identified on today's exam that have imaging features concerning for cancer. One of your nodules is shown to the right.

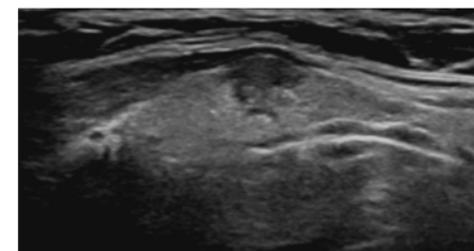
You have at least one nodule (shown to the left) that has imaging features concerning for cancer, including irregular borders and microcalcifications.
